Supporting Information

Electron beam lithography for direct patterning of MoS₂ on PDMS substrates

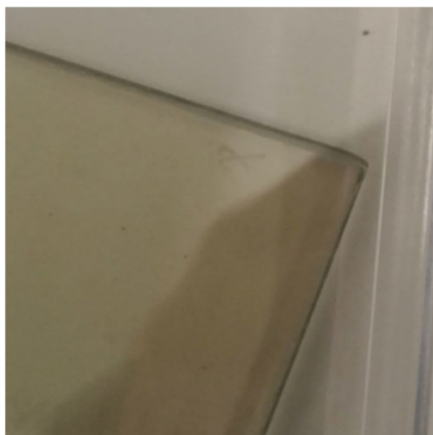
Figure S1. Photograph of the MoS₂ film grown on 10x10 cm glass substrate.

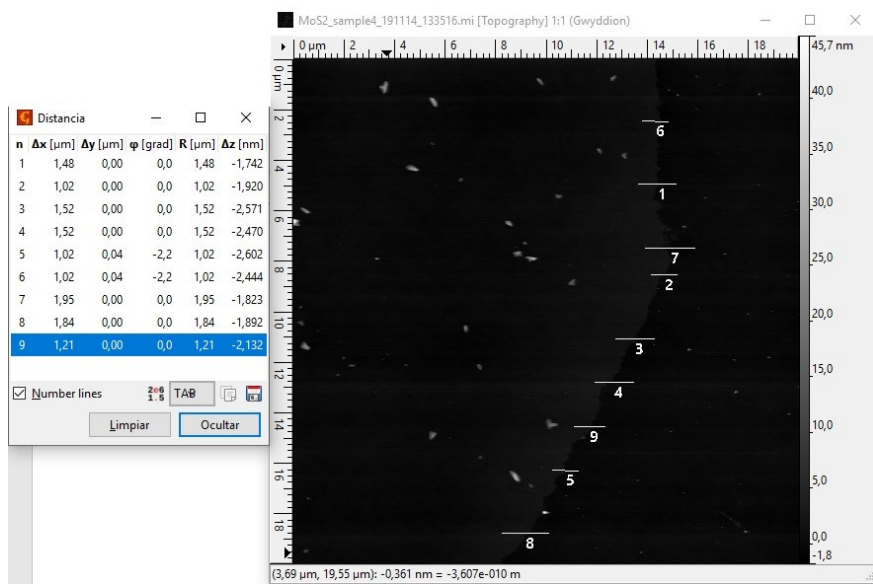
Figure S2. Atomic force microscopy measurements of the thickness of the MoS₂ film.

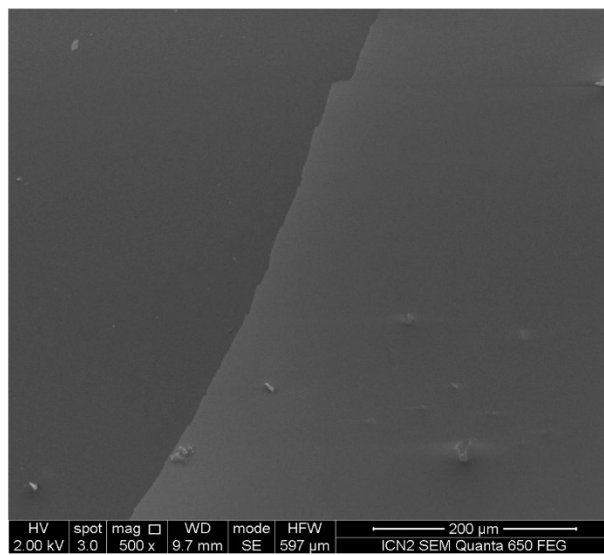
Figure S3. Scanning microscope image of the MoS₂ film grown on glass substrate.

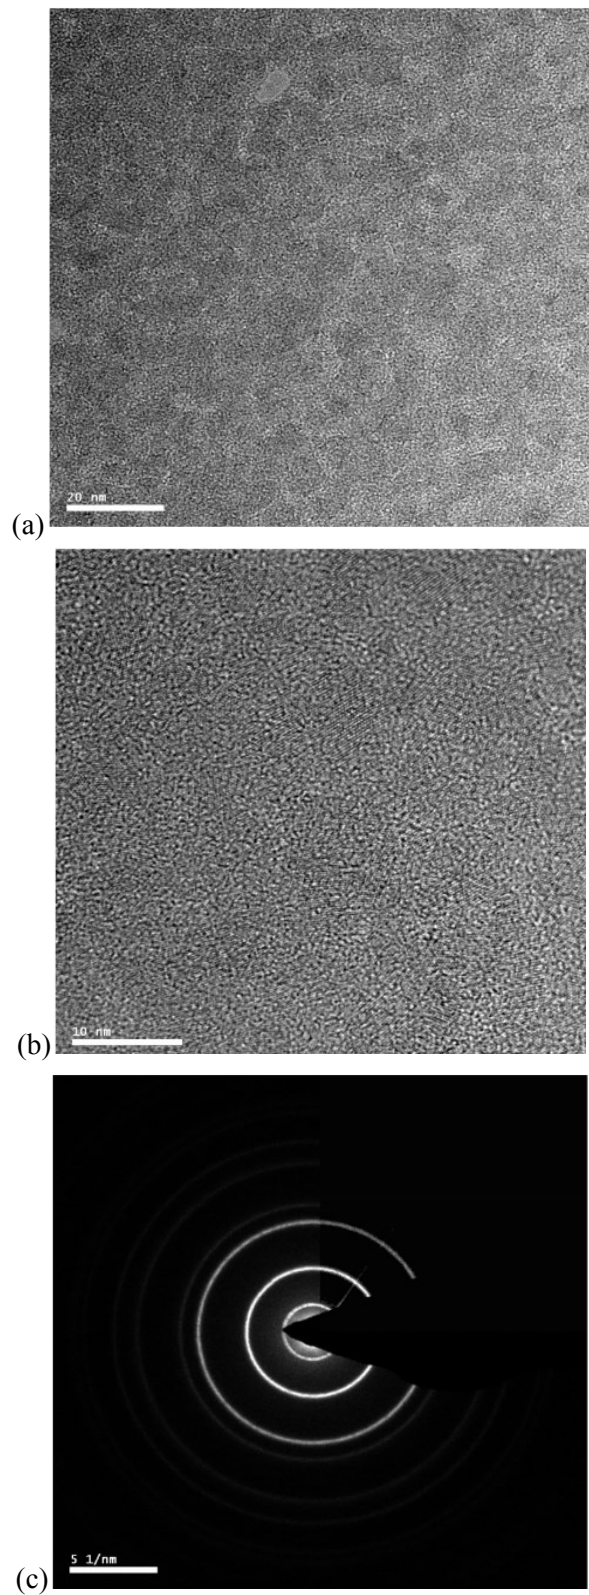
Figure S4. (a),(b)Transmission electron microscopy images and (c) diffraction pattern of the MoS₂ film, showing its clear polycrystalline structure.

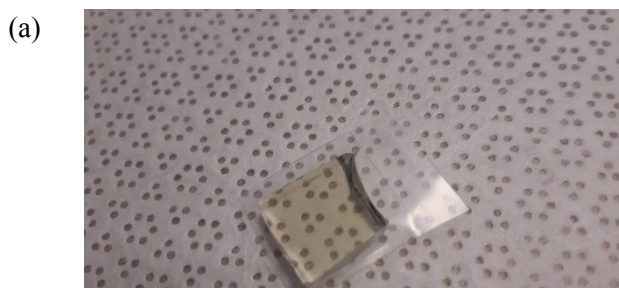
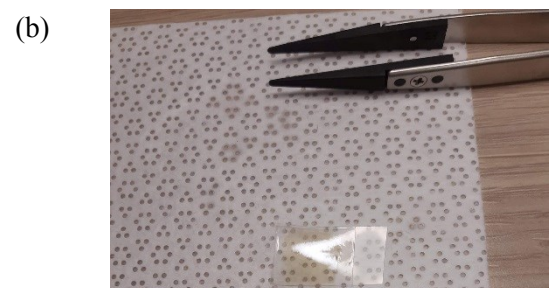
Figure S5. Wet transfer of MoS₂ from the original glass substrate. (a) PDMS directly in contact with MoS₂ on glass, a drop of DI water being placed at the interface (b) MoS₂ transferred to PDMS.

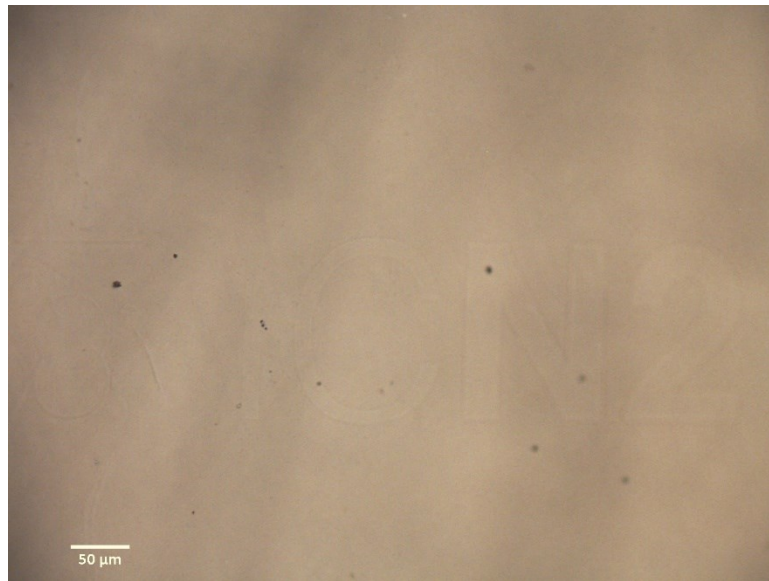
Figure S6. Example of the ICN2 logo exposed on PDMS/MoS₂ using 10 kV acceleration voltage and 300 μC/cm² dose.

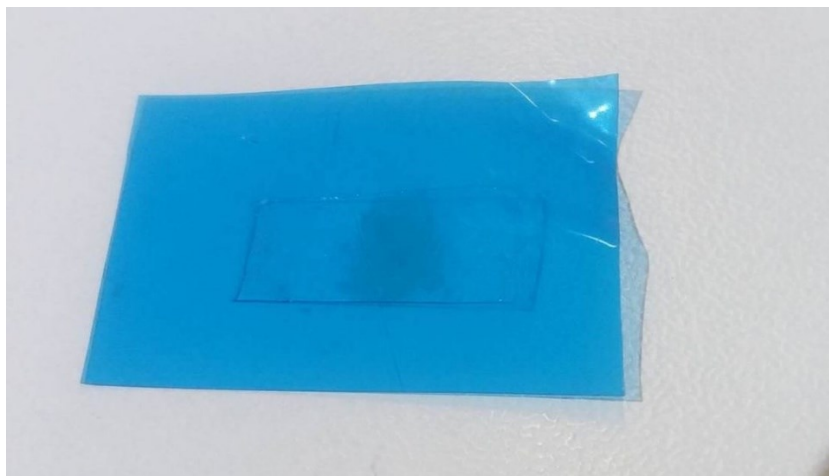
Figure S7. Dry transfer from the PDMS after EBL to the PET substrate.

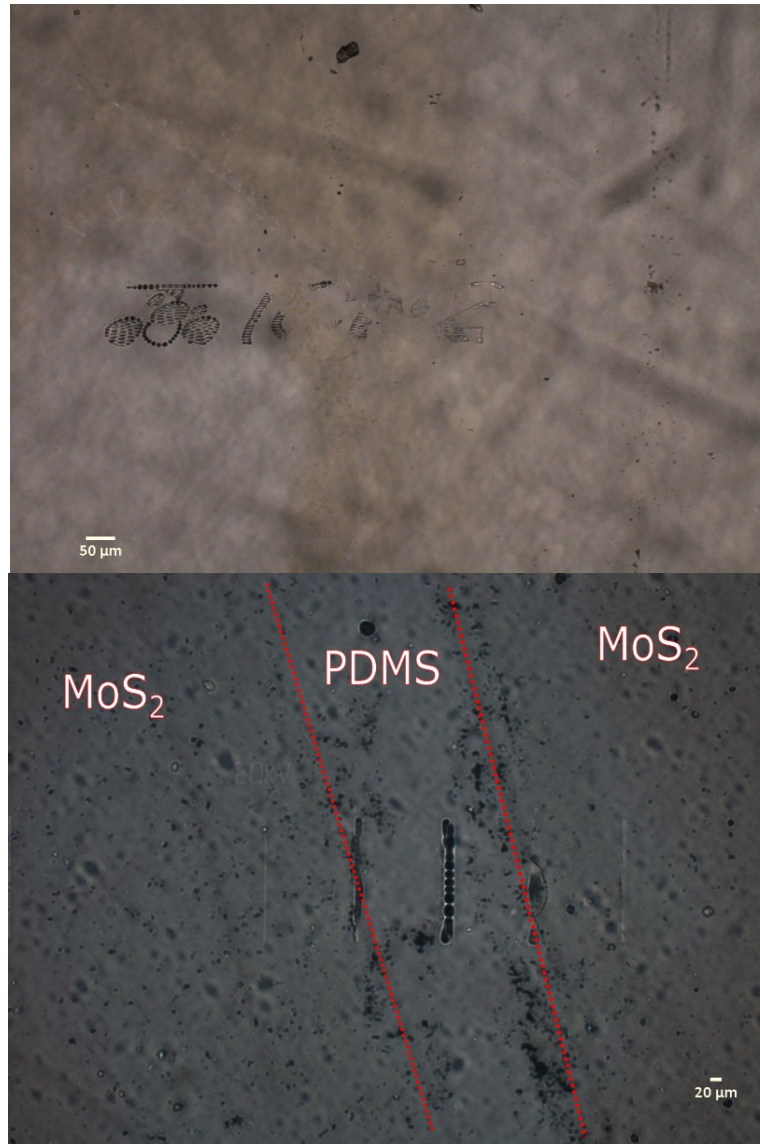
Figure S8. Examples of the EBL on MoS₂/PDMS. The exposures of PDMS only results in black, not well defined patterns. The exposures of MoS₂/PDMS yield well defined patterns. Top:10 kV acceleration voltage and 400 μC/cm² dose. Bottom:20 kV acceleration voltage and 700 μC/cm² dose.

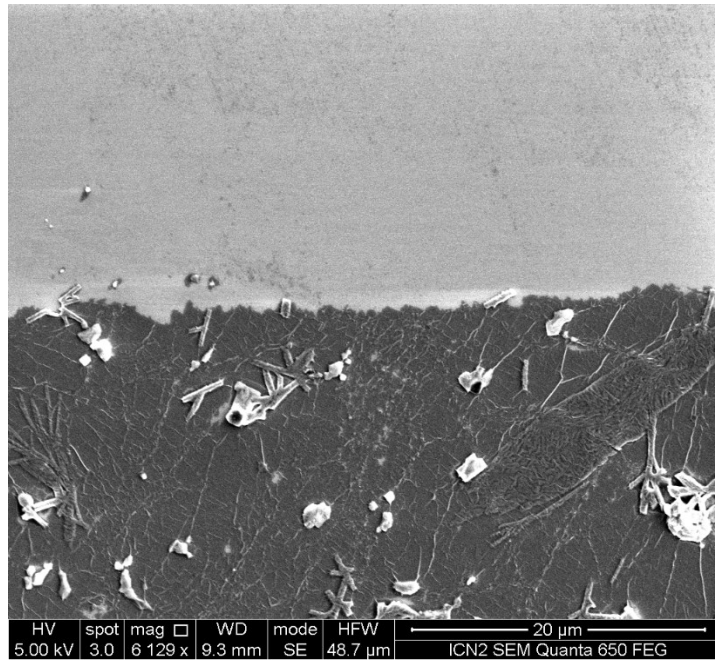
Figure S9. Example of an unsuccessful transfer of MoS₂ from PDMS to Si/SiO₂. The MoS₂ is clearly wrinkled and broken.
