Supporting Information

Insight into the Failure Mechanism in Large-scale 18650 Lithium-Sulphur Cell

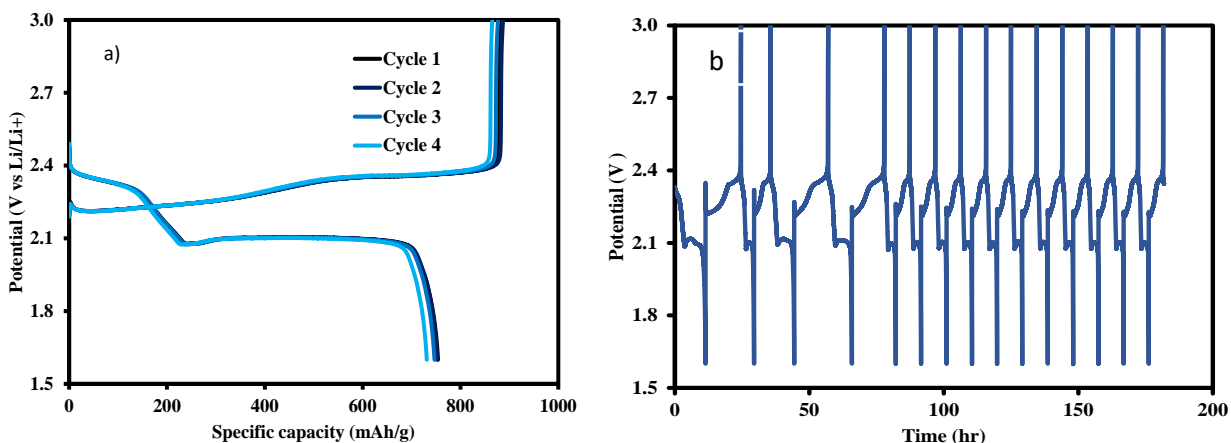
Fig. S1 Coin cell with co-binder CMC:SBR illustrates a) normal discharge profile and discharge plateau contribution at 1C and b) charge/discharge profile at 0.1C at first 4 cycles and 1C at latter cycles.

To compare with the 18650 cell, coin cells using the same type of electrode were also fabricated. The coin cell exhibited a normal discharge profile and demonstrated greater stability than the cylindrical cell, as shown in Fig. S1a and Fig S1b.

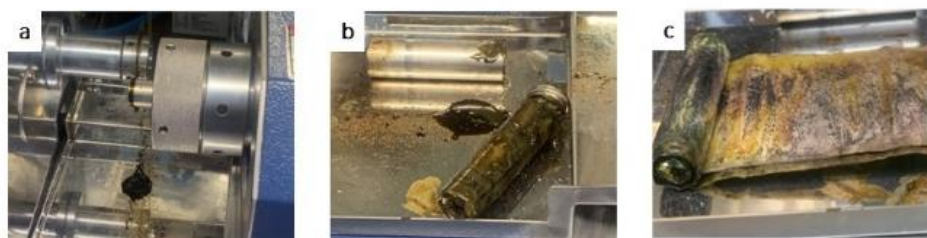
Fig. S2 Cell disassemble illustrating the electrolyte residue leakage during disassemble (a), cell roll and electrolyte residue out of the case (b), and the electrode surfaces (c).

Disassembly of the 18650 cell was conducted to investigate its internal components. It was observed that the electrolyte solution turned dark in colour and became thicker, as shown in Fig. S2a. The electrode after cycling showed signs of corrosion and rough surfaces, with yellow and black residue, which might have resulted from the accumulation of poly lithium sulphide. In Fig. S3, a comparison was made between the fresh electrode and separator with their counterparts after cycling. The cathode showed a rough and corroded surface in Fig. S3a.

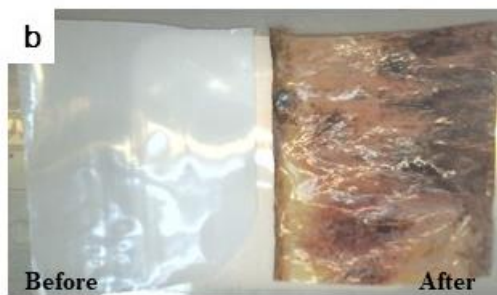
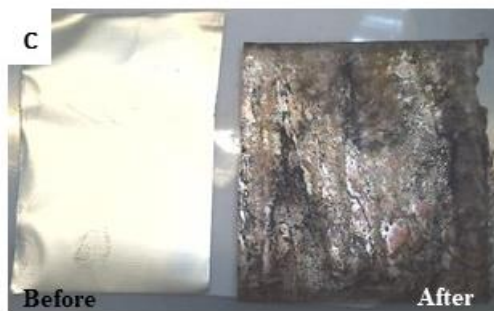
Fig. S3 Cell disassemble before and after cell cycling of (a) sulphur cathode (b) PE/PP/PE separator and (c) lithium metal anode.

The separator underwent a noticeable colour change, transitioning from white to yellow-orange, and displayed dark areas (Fig. S3b). This change suggests the generation of poly lithium sulphide from the cathode, which might have penetrated and accumulated at the separator. The dark areas in the separator originated from the anode side, where the lithium anode reacted with poly lithium sulphide in the electrolyte.

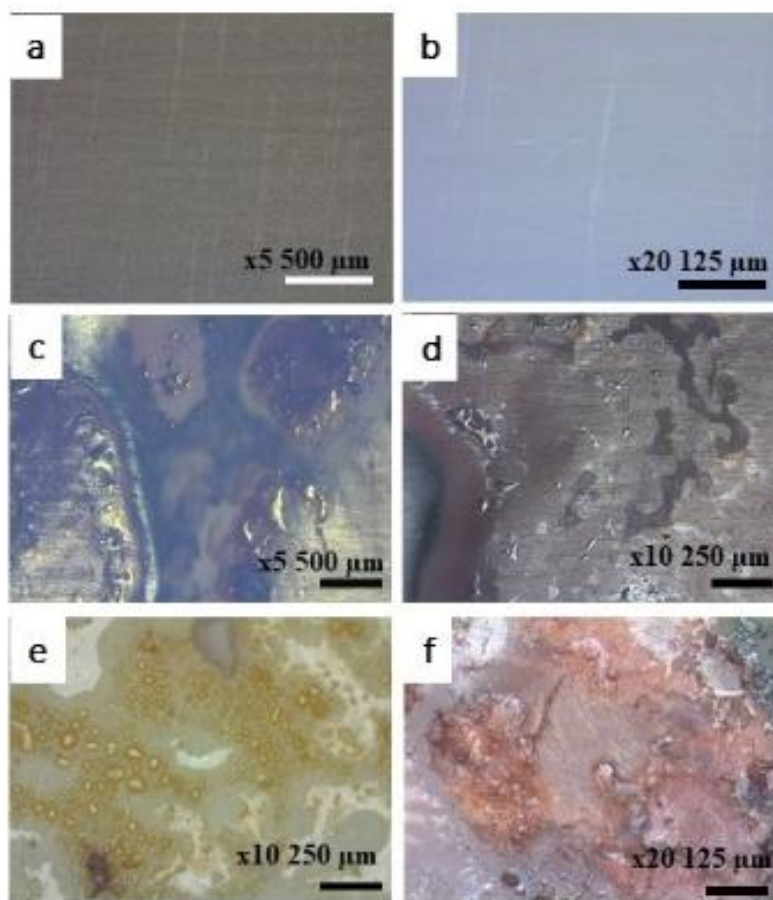
Fig. S4 Optical microscope images of PE/PP/PE separator surface before cycling (a, b), anode side PE/PP/PE separator surface after cycling (c, d), and cathode side PE/PP/PE separator surface after cycling (e, f).

After conducting the GCD measurement, the cell was disassembled, and its components, i.e., cathode, anode, and separator, were analysed using an optical microscope. Samples were taken from the middle of the length and width of the electrode and separator within the glove box. It was observed that corrosion occurred severely from the inner roll to the outer roll, with the outermost roll experiencing minimal corrosion.

Fig. S4 illustrates the PE/PP/PE separator in LSBs. Before cycling we can observe the clear surface of the separator under microscope in different magnifications (Fig. S4 a,b). After galvanic charge discharge evaluation, the separator showed a wet and rough surface. The separator was wet and its color changed from white to yellow to orange as indicated in Fig. S3b and Fig. S4c-d. On the cathode side of the separator (Fig. S4e-f), it tended to get a darker color from the lithium anode reaction. It might be from the lithium dendrite and a consequence short circuit. While on the cathode side, the separator turned to yellow and orange. This may occur from the color of polysulfide produced from the cathode. The electrolyte solution turned from a colorless solution to dark yellow to black. This indicates the reaction in the electrolyte.

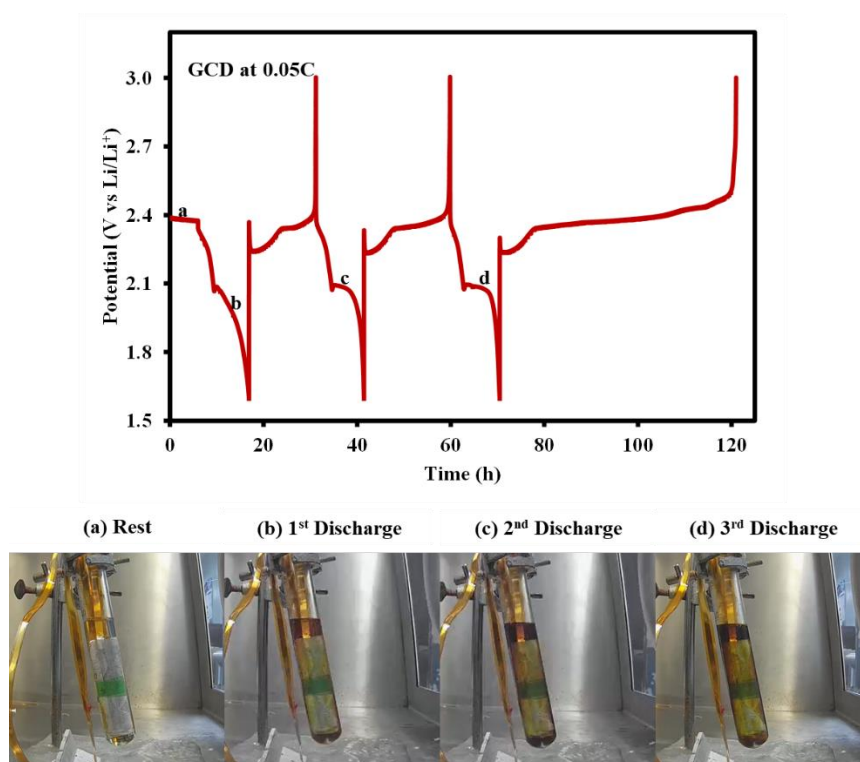
Fig. S5 the accumulation of higher concentration of the polysulfide dissolved into the electrolyte as time and number of cycles increase.

During the GCD (Galvanostatic charge-discharge) experiments, the electrolyte was closely observed. Over time, a noticeable color change was observed, transitioning from colorless to yellow. To document this observation, a video of the electrolyte investigation was set up. You can view the video from the links provided below:

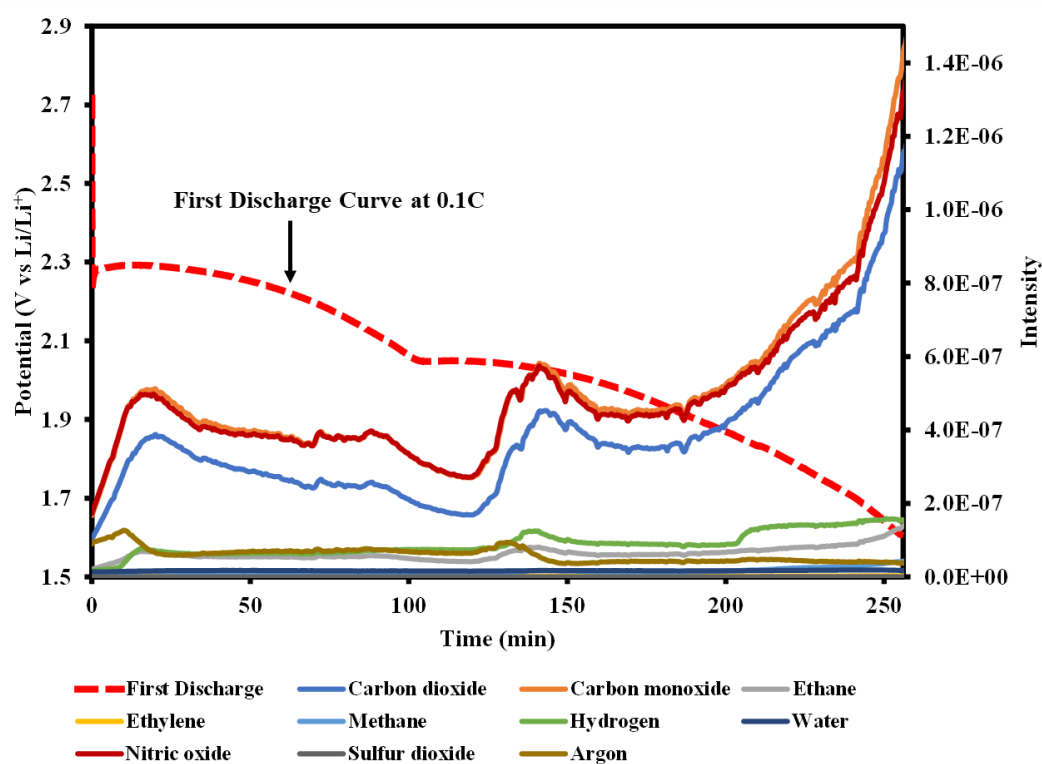
Fig. S6 The first discharge profile and relevant of the gases produced from the jelly roll.

The jelly roll was fabricated and subjected to GCD at 0.1C. During the first discharge, the gases produced were detected using differential electrochemical mass spectrometry (DEMS).

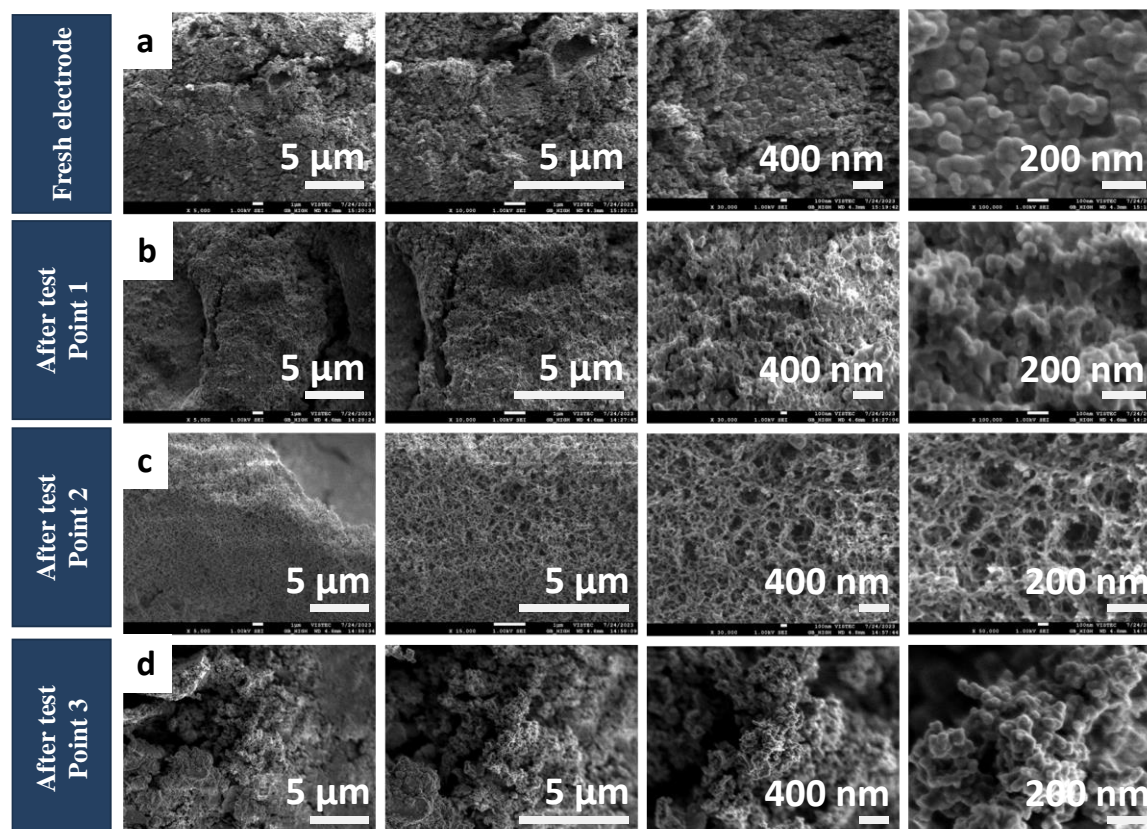
Fig. S8 FESEM images of the cathode a) before and b), c), d), after cell cycling at the position of the beginning, the middle, and the end of the roll.

Furthermore, the SEM images of the cathode after GCD were also investigated. These images were taken from three positions along the roll, i.e., the inner roll, middle roll, and outer roll, at specific locations: 1 cm, 23 cm, and 45 cm from the total cathode length of 47 cm.

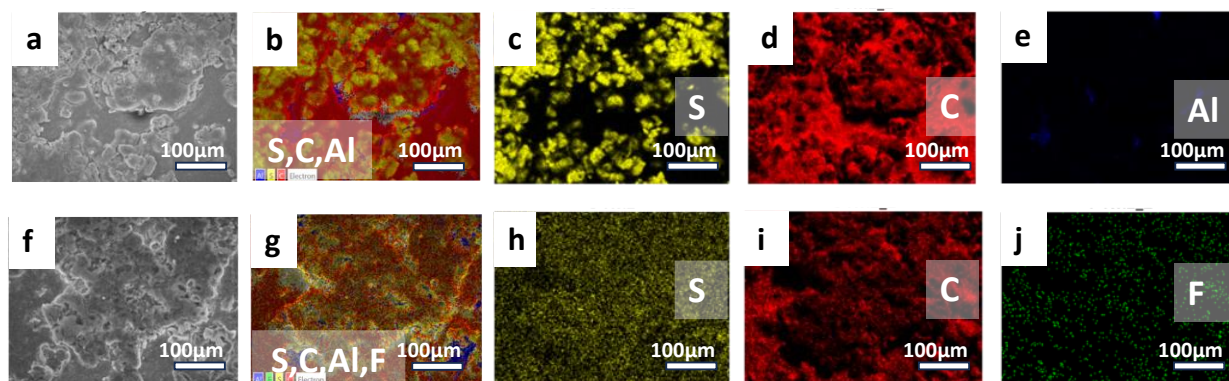
Fig. S9 SEM images of z) fresh cathode illustrating the element contains in b), c), d), e) and f) cathode after cycling f with EDX analysis illustrating elemental contains information in g), h), i), and j).

SEM images of the cathode were captured before cell fabrication using the as-prepared electrode sample, providing insights into the material's morphology, coating thickness, and sulphur element composition, as depicted in figure 1. These SEM images were obtained from the pressed electrodes following the calendaring process, specifically from the centre of the electrode sheet. Throughout the manufacturing process, we closely monitored the thickness and uniformity of the electrode sheet to maintain our quality standards. This meticulous monitoring ensured a representative view of the electrode's microstructure. Due to the constant measurement of the sheet's thickness and uniformity, there should be minimal spatial variation, making the centre a suitable point for general inspection.
