## ELECTRONIC SUPPORTING INFORMATION

### Environmental and Private Property Contamination Following the Norfolk Southern Chemical Spill and Chemical Fires in Ohio

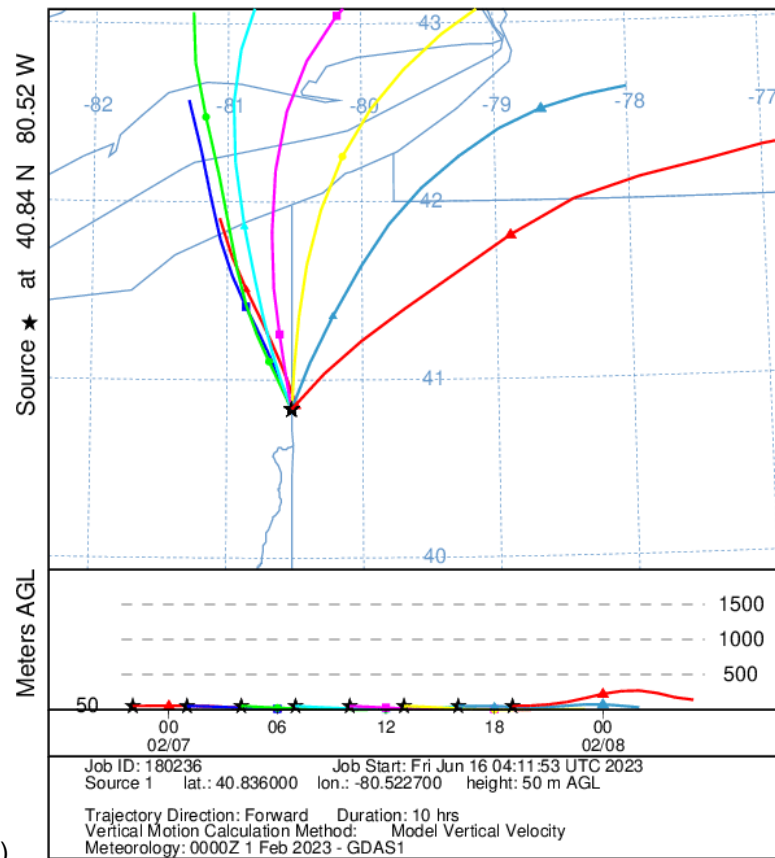
Figure ESI-1. (a) A map of some of the forward trajectories starting at 50m AGL of the spill site at the time of the train derailment. This map clearly shows the air from this location moved towards east, southeast, and north of the spill site (b) A map of the forward trajectories starting at 50m AGL of the spill site at the time of the controlled burn. This map clearly shows the air from this location moved mostly towards north of the spill site.

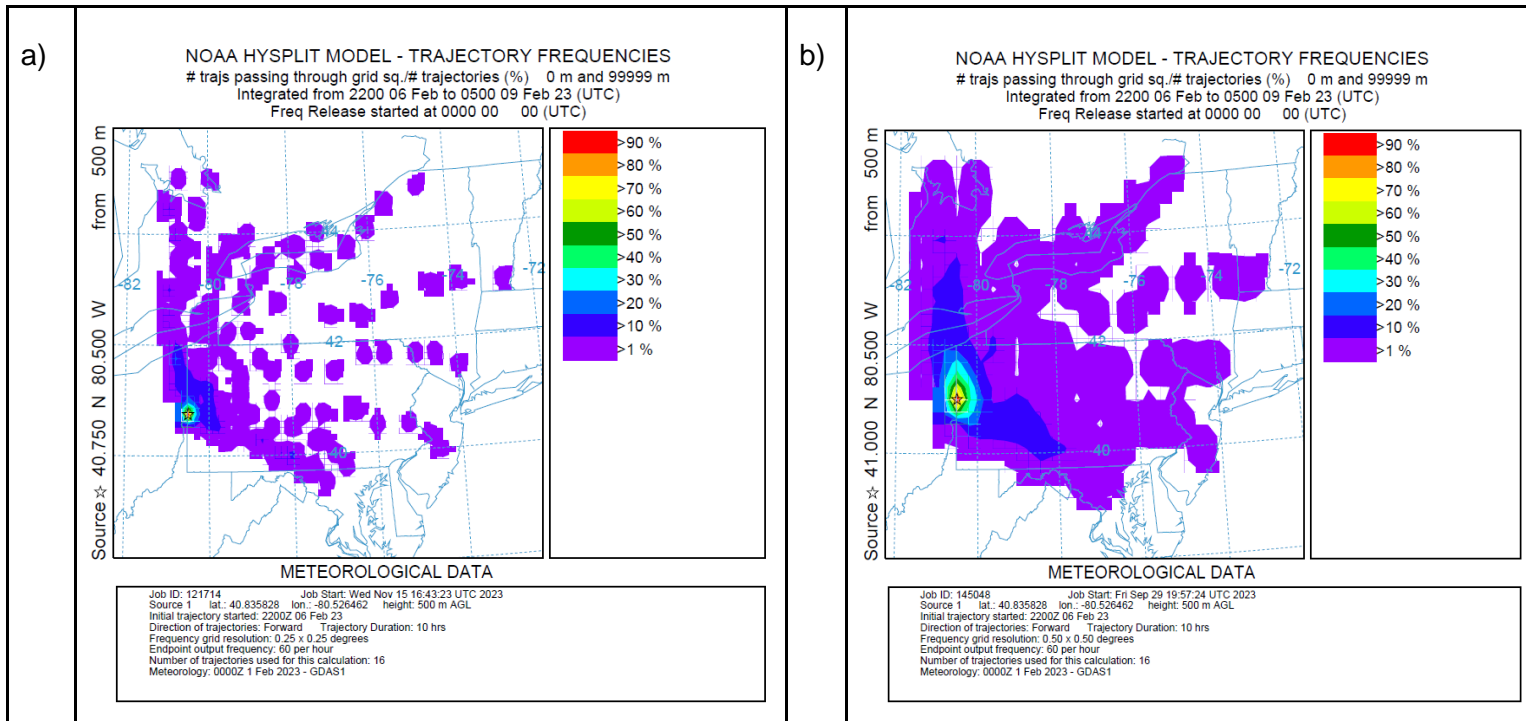
Figure ESI-3. The grids in the model are fixed based on the selected spatial resolution, which is used to calculate the trajectory of an air parcel.

After the model calculates the trajectories, it likely assigns colors to each grid based on the fraction of trajectories passing through it, using a specified color scale. Consequently, the center of the frequency plot can be spatially offset from the actual starting location (the derailment site). This discrepancy becomes evident when the model is run at different spatial resolutions, represented by trajectory frequency plots at 0.25, 0.5, 1, and 2 (labeled as a, b, c, and d, respectively). Since the only difference among these plots is the model resolution, it is evident that these variations are artifacts resulting from the grid resolution in the HYSPLIT model.

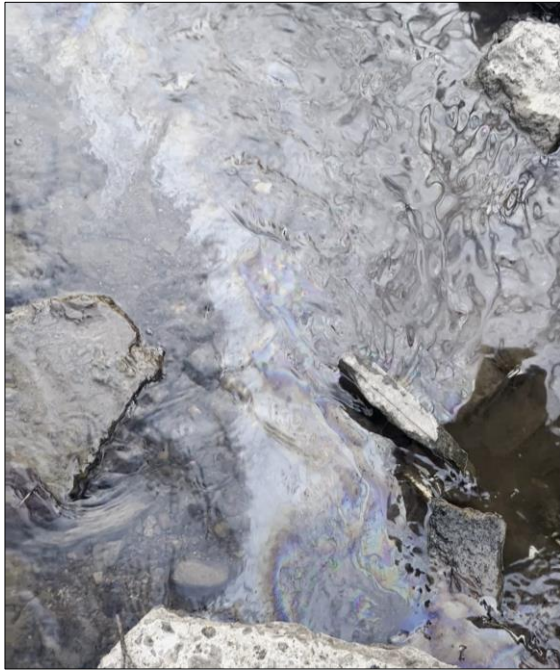
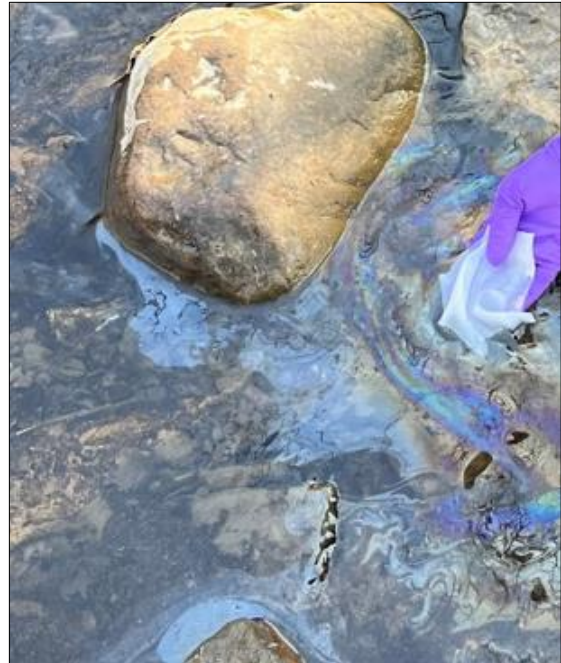
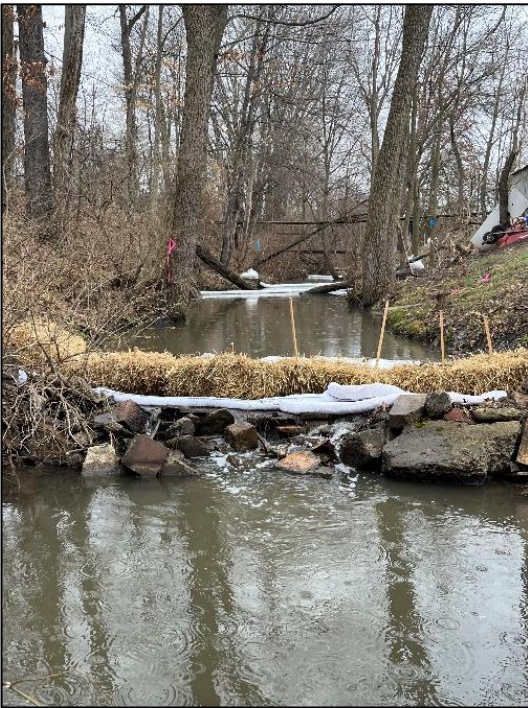
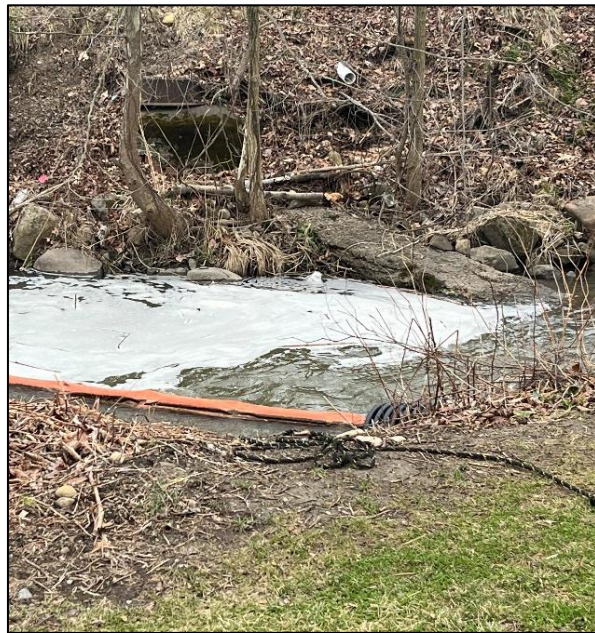
**Figure ESI-6. Sheen was observed freely flowing in (a) Sulfur Run and (b) Leslie Run creeks during the first field investigation, including outside the USEPA's "containment area", (c) Sulphur Run 500 feet downstream from the derailment site, and (d) Foam was also observed on the surface of the creeks.**

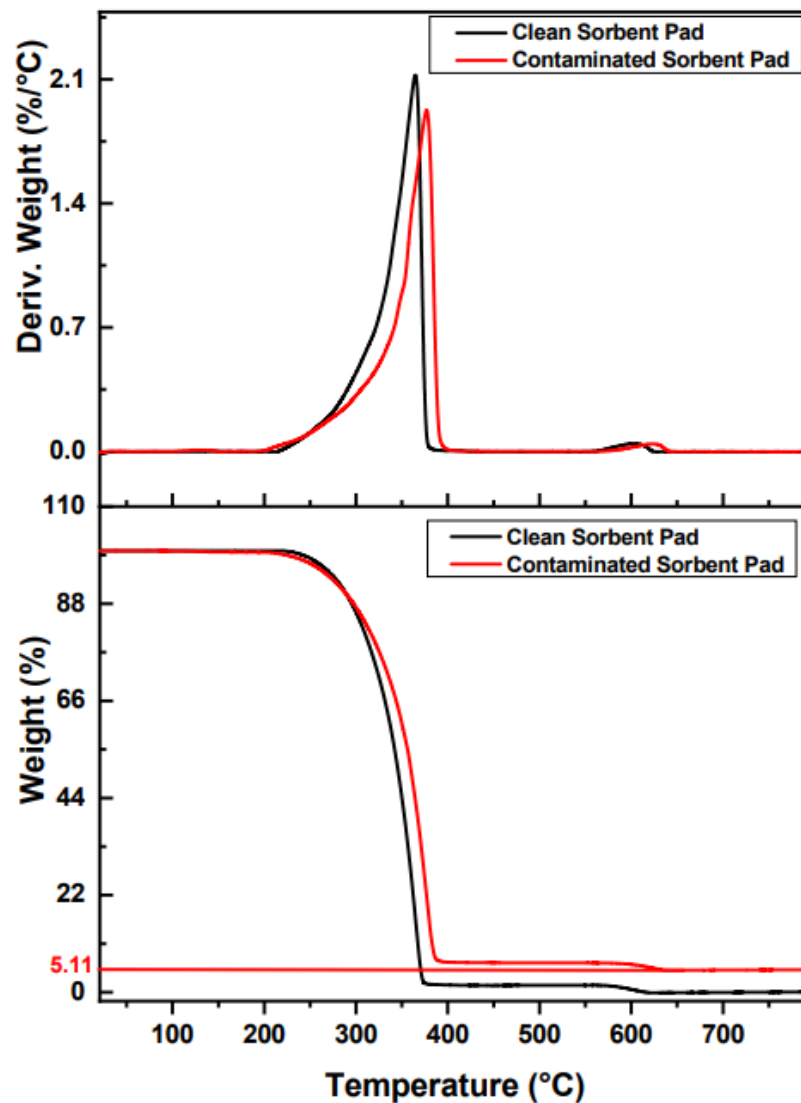
Figure ESI-8. DT-TGA of clean and contaminated sorbent pad.

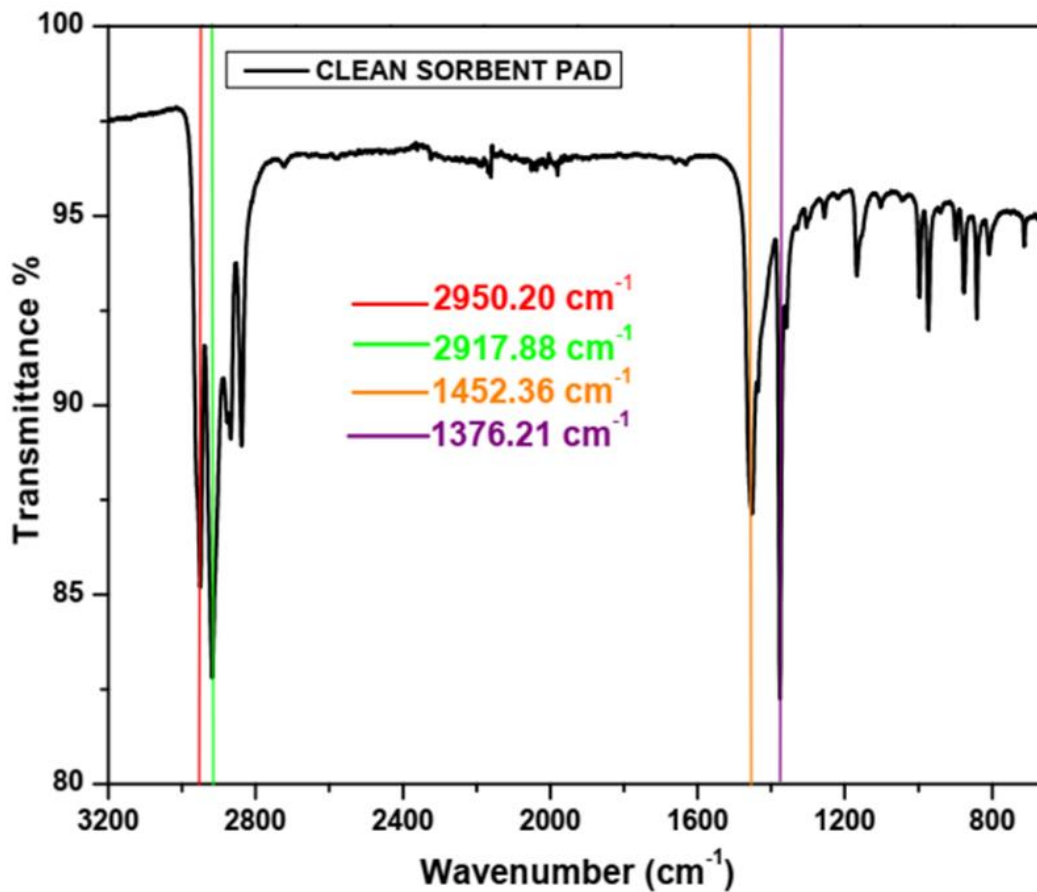
FTIR analysis confirmed the peaks at 2950.20  $\text{cm}^{-1}$ , 2917.88  $\text{cm}^{-1}$  confirm the presence of -CH group,<sup>22-25</sup> peaks at 1452.36  $\text{cm}^{-1}$  and 1376.12  $\text{cm}^{-1}$  indicate the presence of  $\text{CH}_2$  and  $\text{CH}_3$  groups respectively.<sup>22-25</sup> IR performed on the contaminated pad (dried) exhibited one weak peak at 1638.5  $\text{cm}^{-1}$  which indicated either conjugated alkene or alkene, monosubstituted (fatty acids or phospholipids in the river stream)<sup>22</sup> or a deformation mode of molecular water that remained in the contaminated pad after drying<sup>26-28</sup> and rest all other peaks matched with polypropylene spectra.<sup>22-25</sup>

Figure ESI-9. ATR-FTIR spectra for a clean sorbent pad indicating that the product was polypropylene.

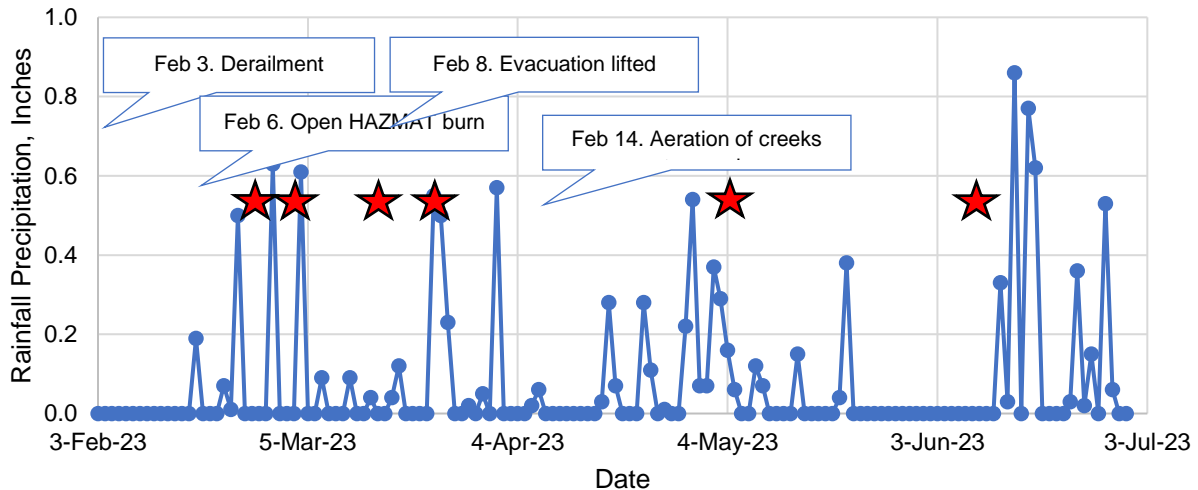
**Figure ESI-11. Timeline of field investigations compared to measured precipitation events.**

Stars indicate the date of the author’s field investigations (February 25-27, March 3-4, March 17-19, March 23-25, May 4-5, June 8-10). Other key activities are shown.

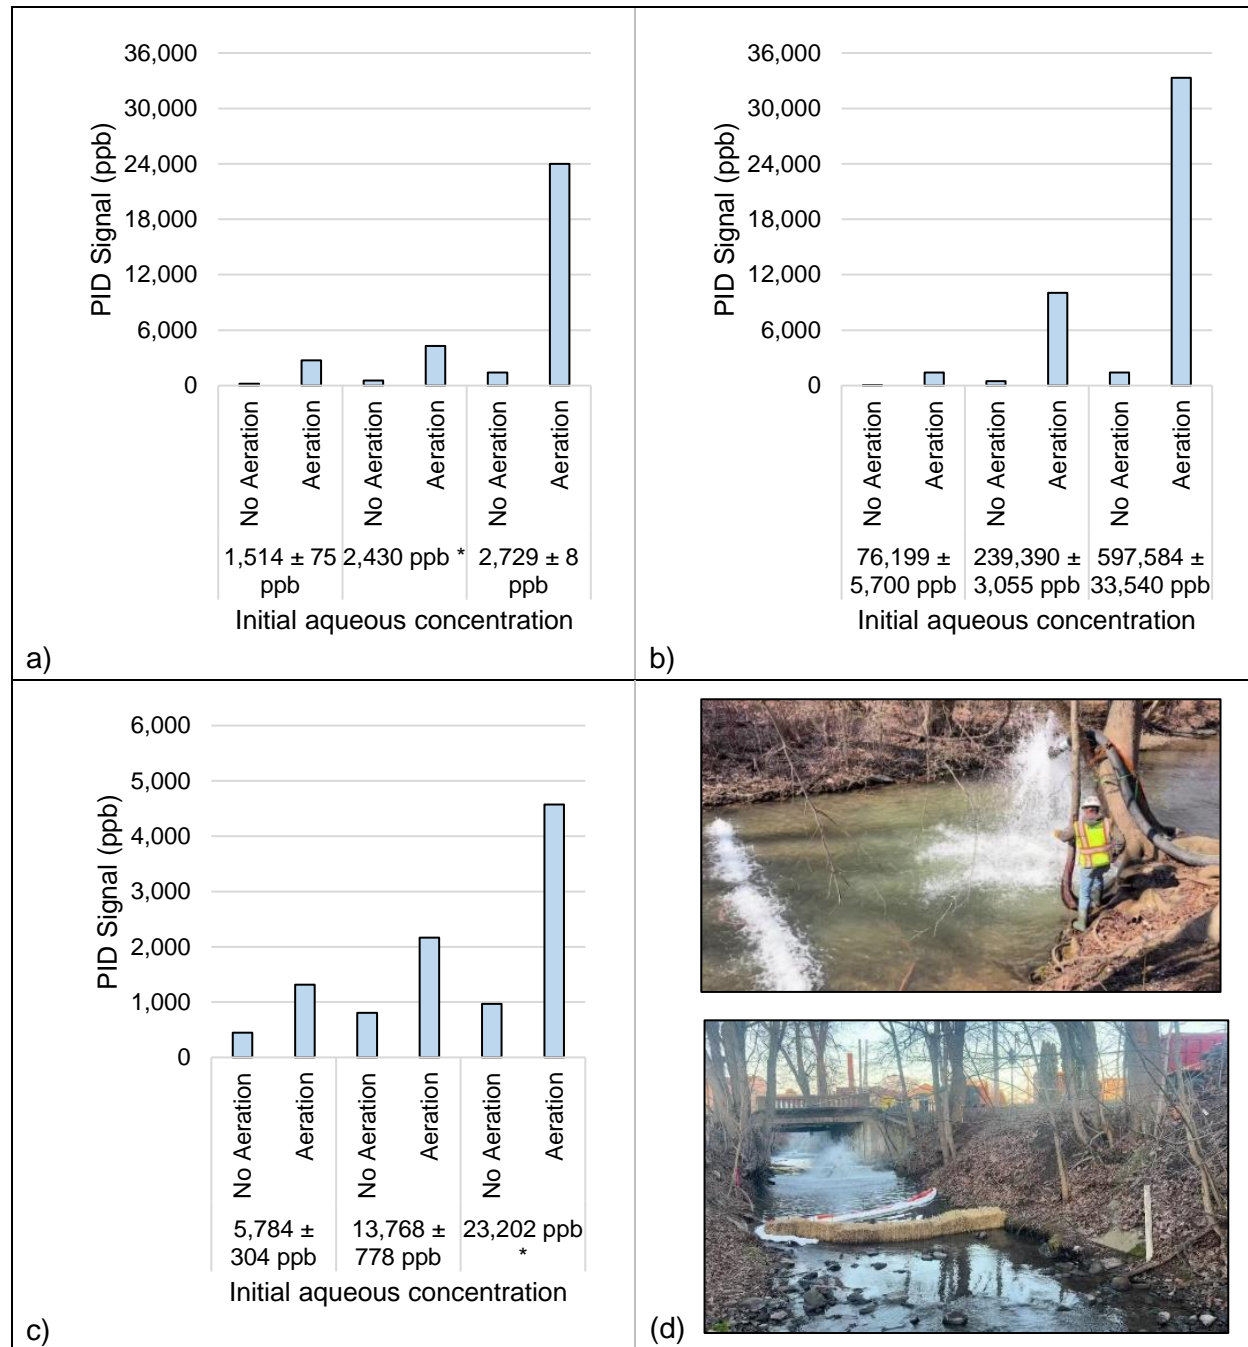
**Figure ESI-12. Aeration increased PID signal due to the volatilization of (a) BA, (b) 2-BE, and (c) 2-EHA into the air, and (d) RESP sprayed contaminated water it into the air along Sulphur Run and Leslie Run Creeks, which caused contamination to travel away from the creek banks into nearby areas and buildings.**

15 min average PID signals shown. Mean and standard deviation values for three replicates shown. Standard deviation ranged from < 0.5% to 7.2% depending on the chemical, concentration, and aeration condition. Bubble creek bottom diffusers were also present and volatilized chemicals into the air.

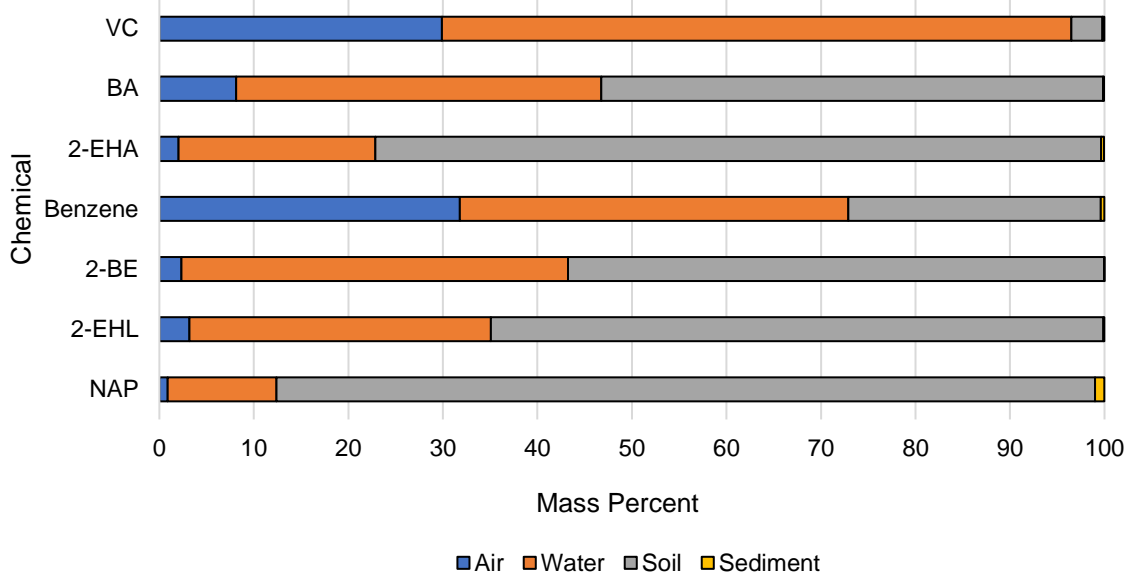
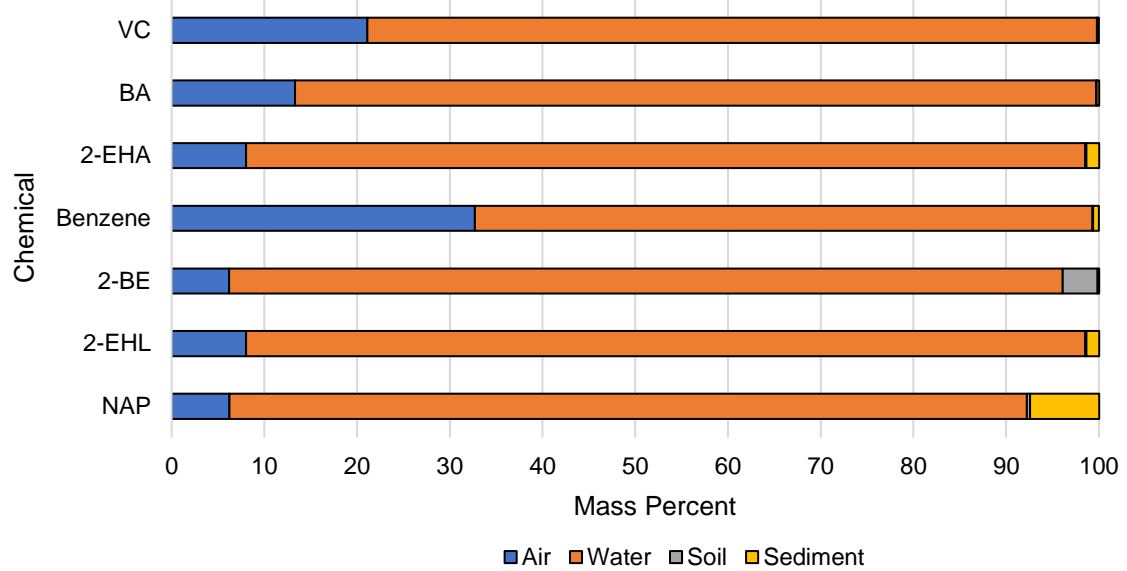
**Figure ESI-13. The mass percent of each chemical transported into each natural resource estimated using the USEPA EPI Suite software (a) when soil was considered as a pathway, and (b) when soil was not considered as a pathway.**

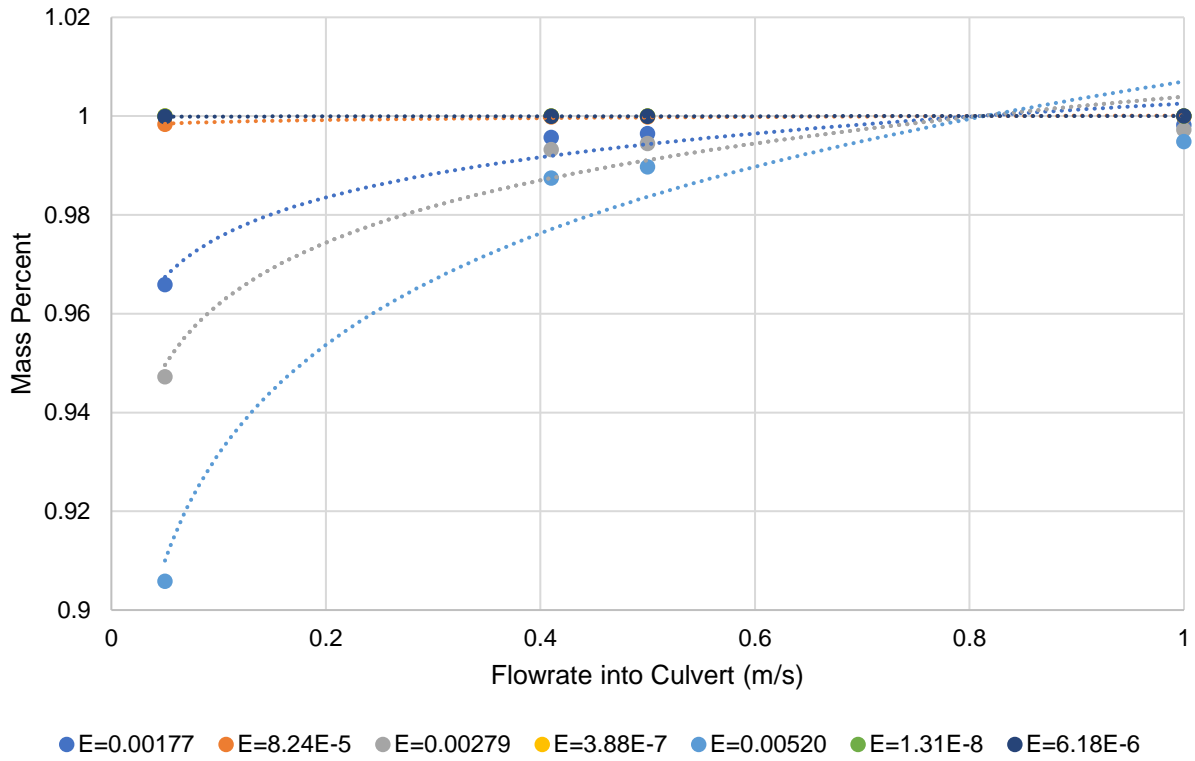
**Figure ESI-14. Results obtained with the USEPA EPI Suite indicated that as the creek flowrates increased, the mass percent of chemical in air in the culvert would increase as well. Several emission rates (E) were evaluated.**

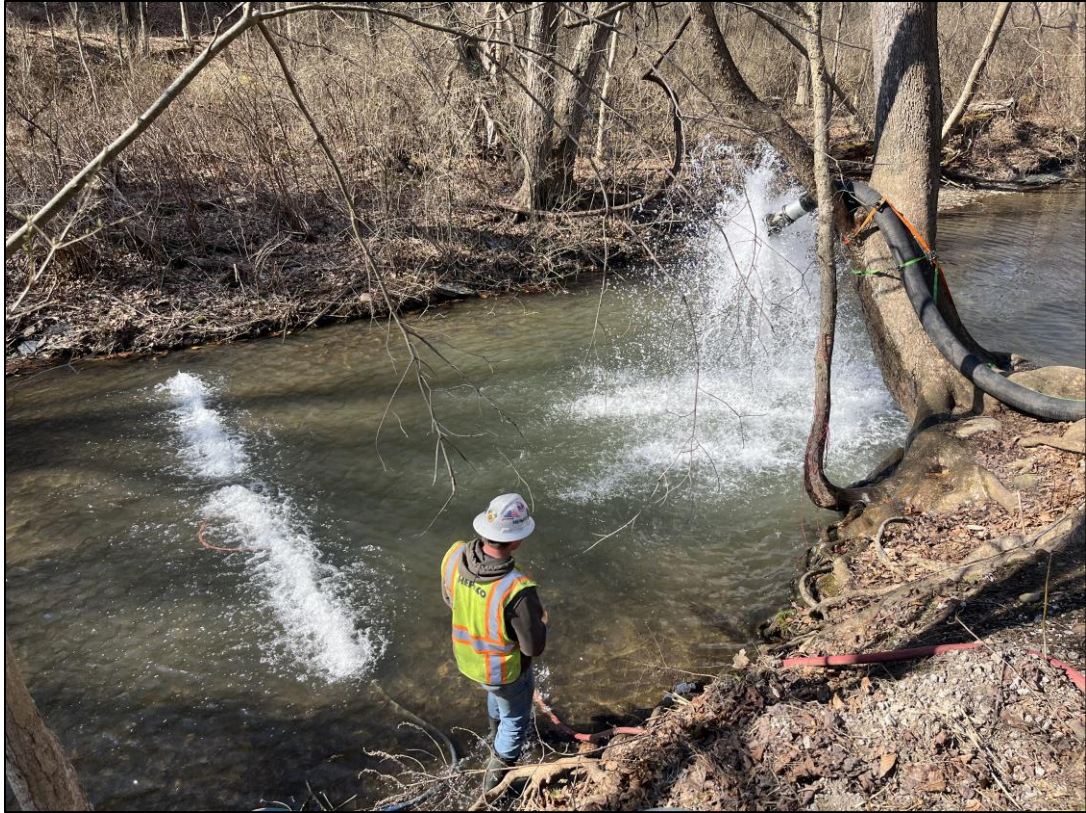
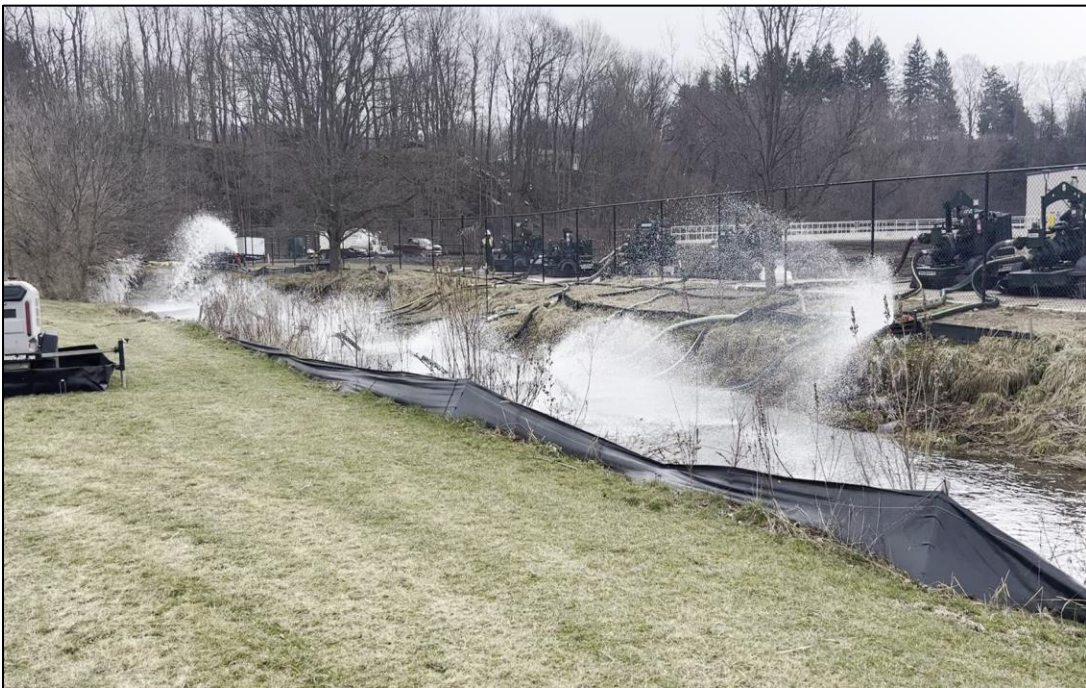
**Figure ESI-15. Mechanical aerators and creek bottom diffuser equipment were operated along Sulphur Run and Leslie Run. This equipment discharged contaminated water and contaminants into the air.**

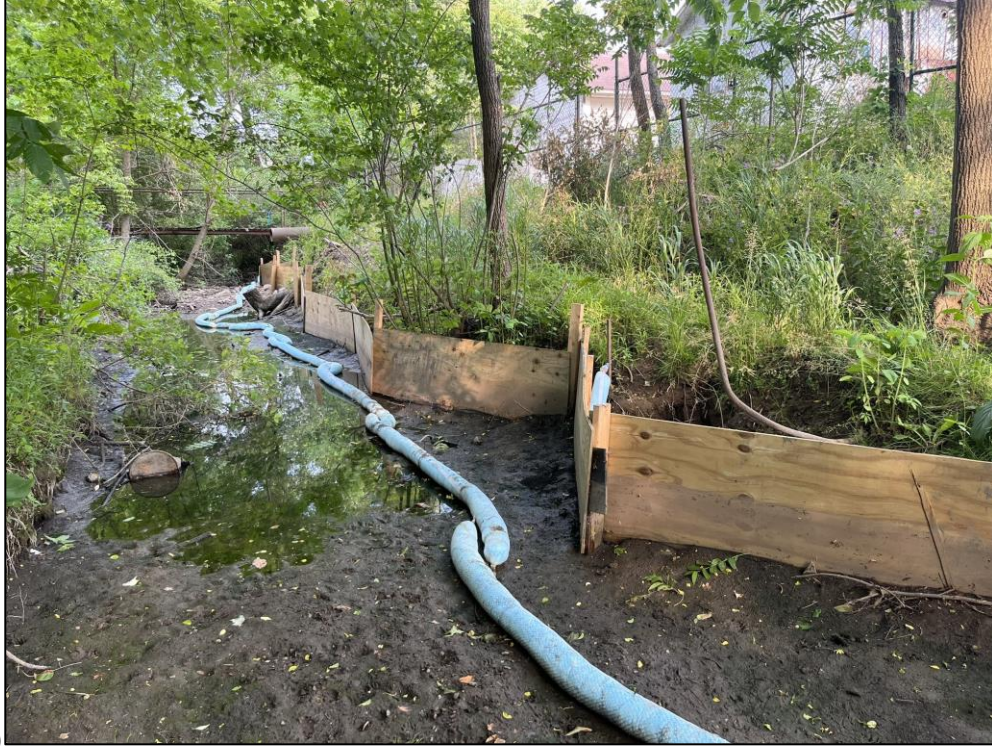
**Figure ESI-16. Sometimes the chemically contaminated creeks were filled with water and other times they were dry, with contaminated sediment directly exposed to the air. Sulphur Run was visited (a) June 10 after three weeks of little rainfall and (b) on June 12, after rainfall.**

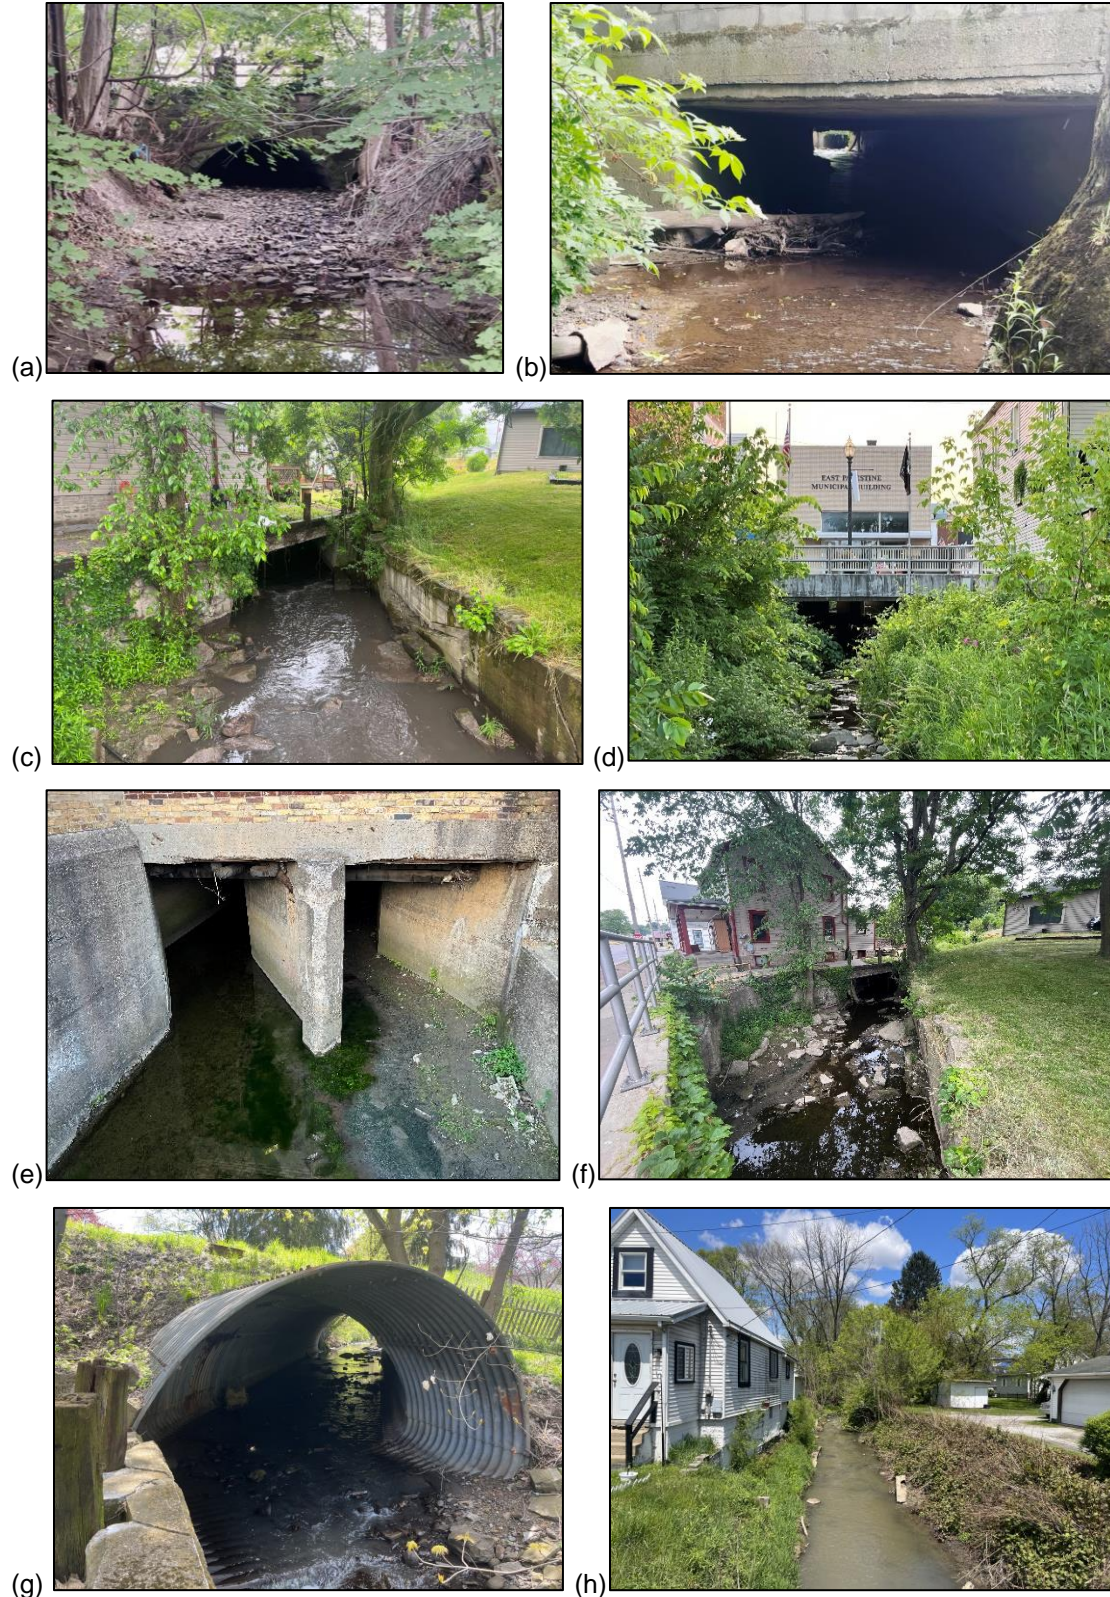
**Figure ESI-17. Concrete and metal culverts transport Sulphur Run water underneath and adjacent to East Palestine roadways, properties, as well as commercial, residential, and municipal buildings.**

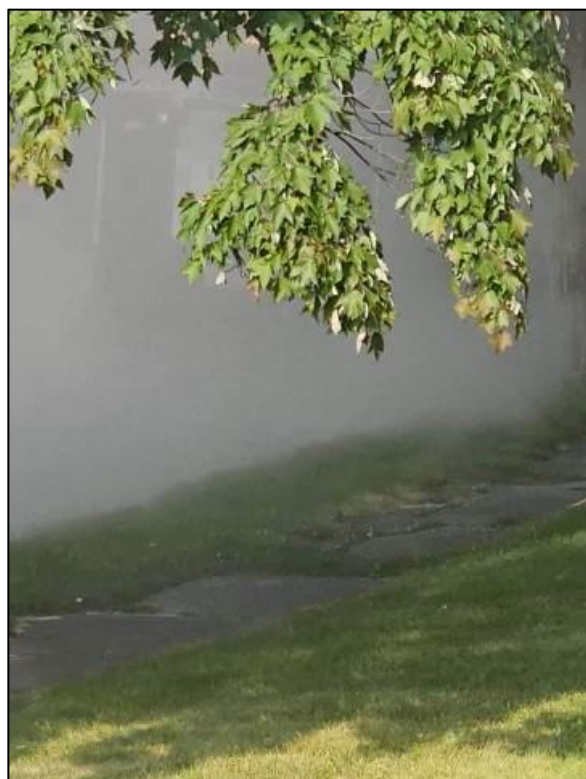
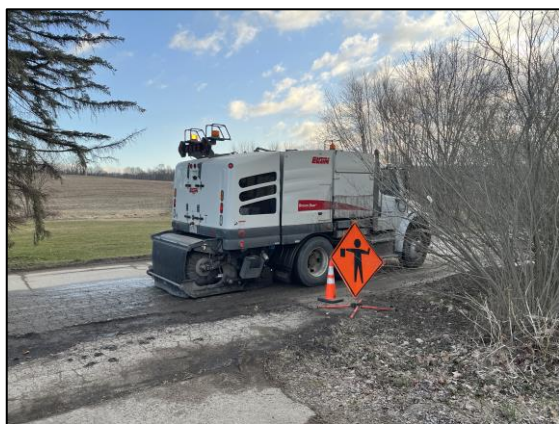
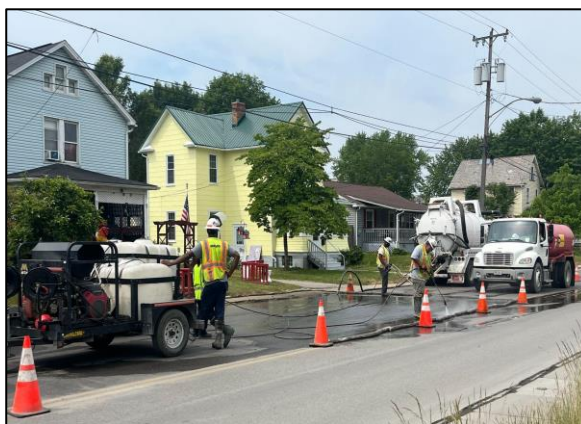
**Figure ESI-18. In East Palestine, Ohio (a) Particulates were seen suspended into the air during recovery along a roadway near the derailment site, (b) street sweepers were deployed near East Clark Street, and (c) contractors were seen pressure washing East Taggart Street near the derailment site. Image (a) was taken by Jake Cozza, other images from author AW.**

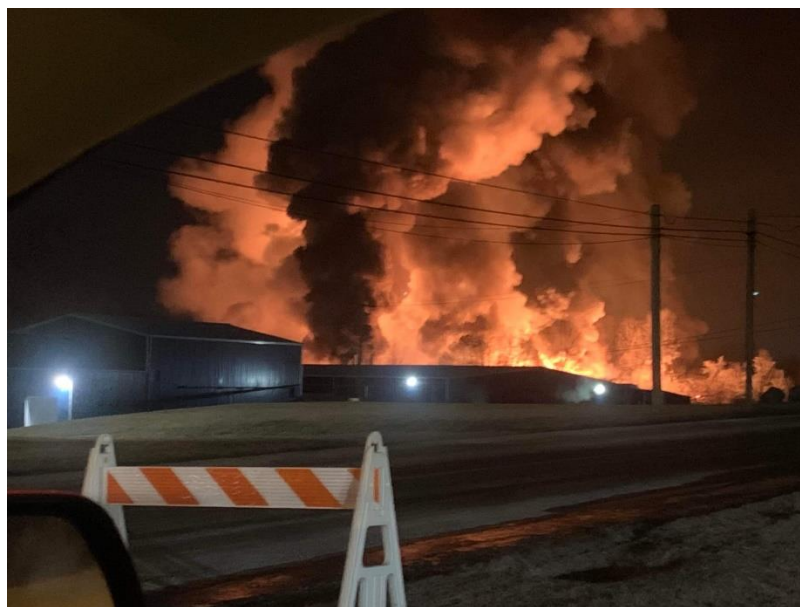
**Figure ESI-22. Nearby residents saw the train wreck fire from East Taggart Street in East Palestine, Ohio looking towards the CERAMFAB building on February 3, 2023, before the open burn was conducted February 6, 2023. Image taken by Lonnie Miller.**

February 6 – Nearby residents saw the train wreck fire from East Taggart Street looking towards the CERAMFAB building.

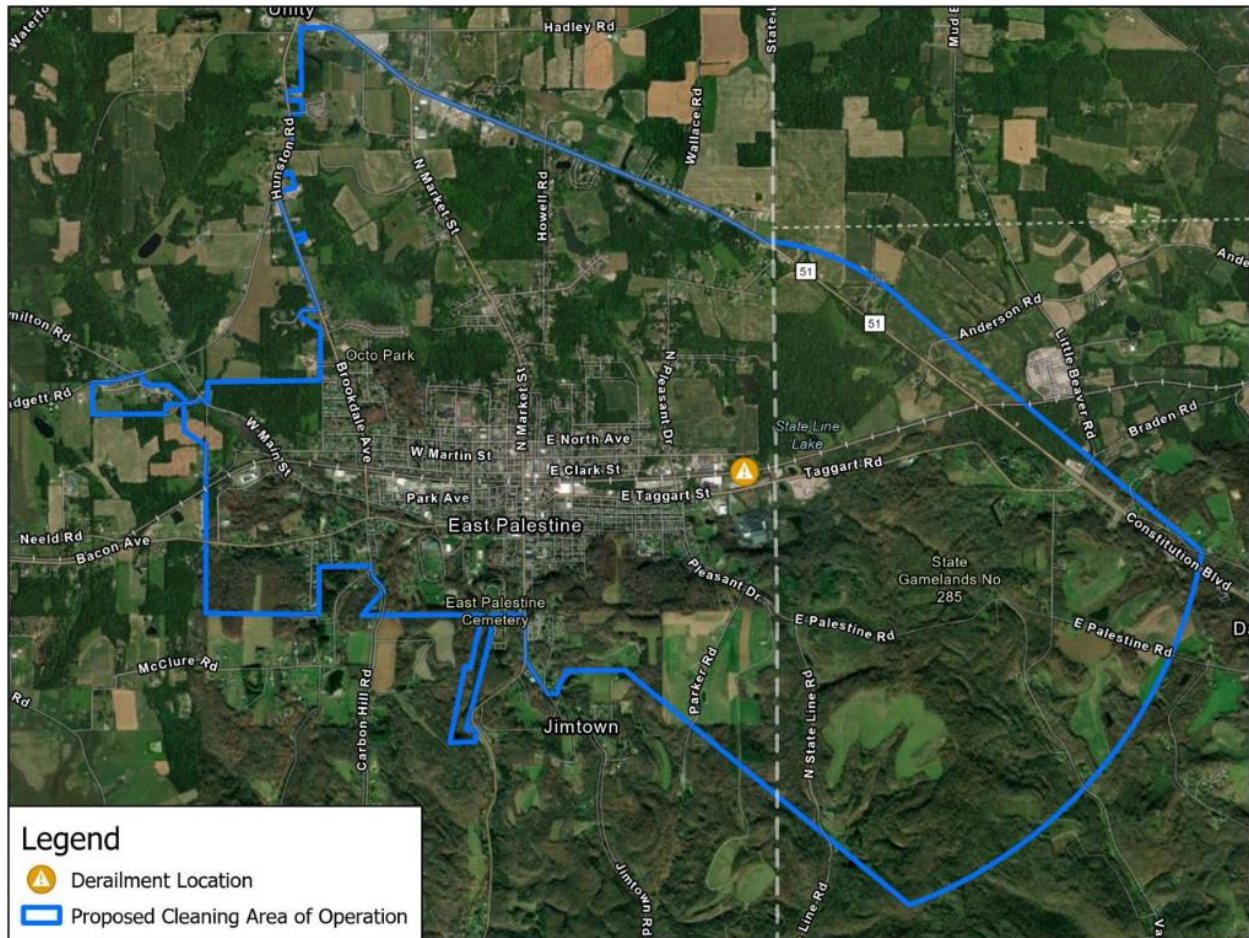
Figure ESI-28. Map of indoor cleaning eligibility boundary per the USEPA.<sup>213</sup>

August 8 – The USEPA issued a map that described the eligibility boundary for buildings where indoor cleaning will be offered. Residents are given until September 5 to express interest and will then meet with both Norfolk Southern and USEPA to discuss the details.<sup>213</sup>
