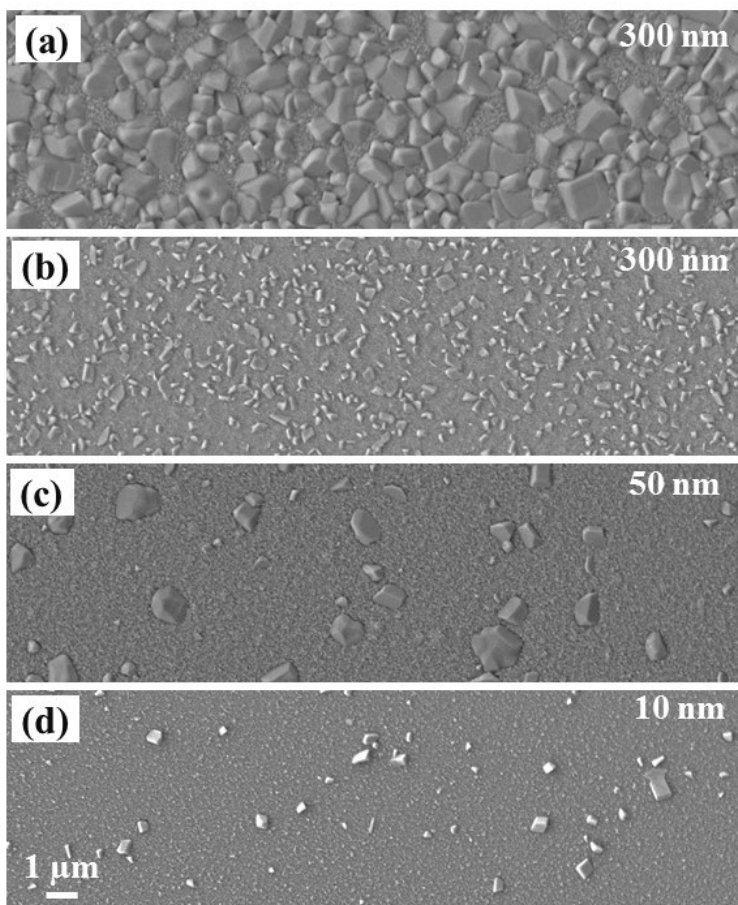
Figure S2 (a) SEM imaging results for sputter deposited Mo films sulfurized at 850°C for 30 min. In (a) the 300 nm Mo film sulfurized using 150 mg of S powder, and in (b), (c) and (d) the 300, 50 and 10 nm films, respectively, sulfurized using 300 mg of S powder. (High magnification images for samples presented in panel (b) and (c) are provided in Figure 1 which confirm the nanosheet presence.)
